6 YEARS OF FOAMED BITUMEN STABILISATION IN NEW ZEALAND – A PERFORMANCE REVIEW AND COMPARISON TO OVERSEAS PRACTICE

Allen Browne
Hiway Stabilizers New Zealand Ltd

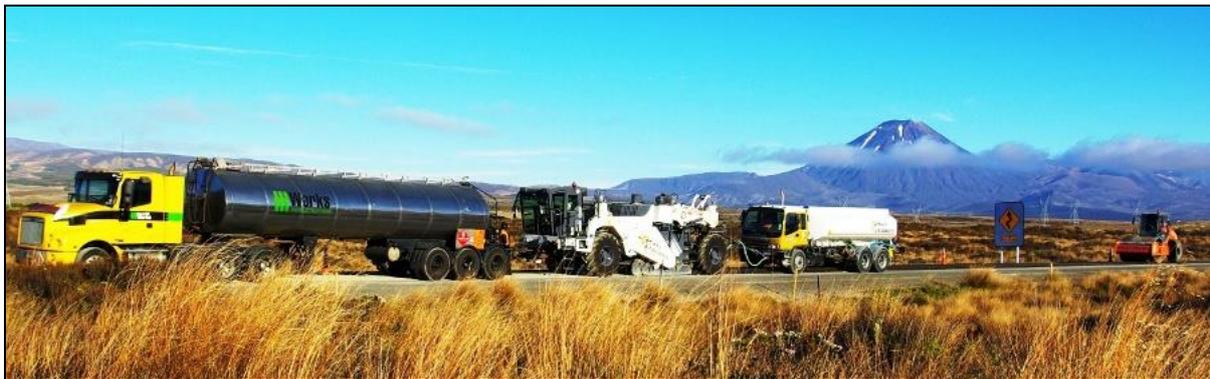
Figure 1: FBS 'train' operating in Tukino, Central Volcanic Plateau, New Zealand.

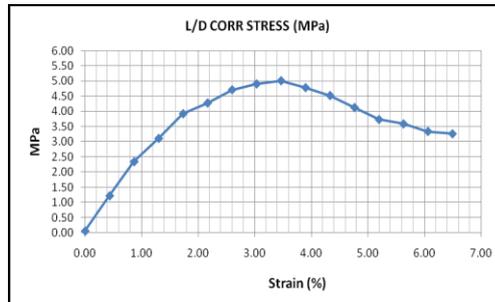
Figure 2: UCS Plot for FBS Dacite

Recent research testing and construction quality assurance has demonstrated that very high strengths can be achieved for some materials. Central North Island dacites, have provided UCS results for 3.0% bitumen and 1.0% cement of 5.0 to 6.0 MPa, significantly higher than typical UCS values of 1.0 to 2.5 MPa. This strength would place the material firmly into the ‘bound’ category for conventional cement stabilising - where the risk of shrinkage or fatigue cracking would be considerable. However, extended compressive strength testing of the FBS samples confirms that the failure mode is ductile - with continued load capacity well beyond 200% strain of the peak

load. This suggests that provided the quantity of active filler is controlled to no more than 1.5%, the visco-elastic properties are maintained despite generating very high strength. Consequently FBS materials do not conveniently fit into conventional Austroads pavement design materials classifications.

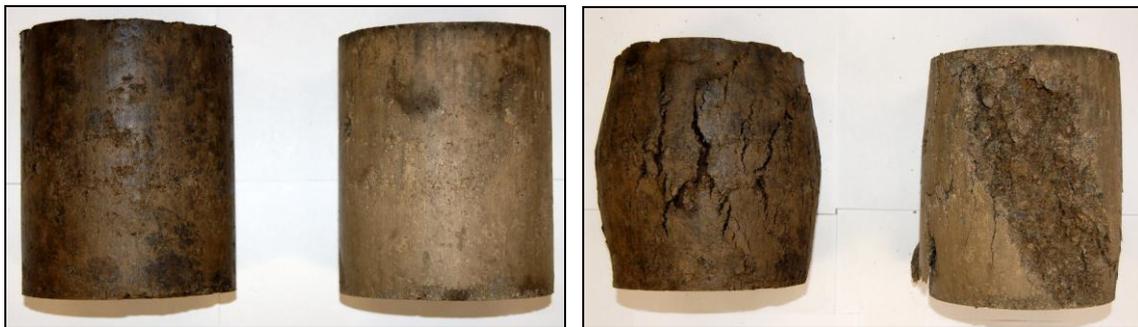
Before UCS Testing

After UCS Testing

Figure 3/3A: FBS (3.0% bitumen % 1% Cement) V Cement-only (4+%) Briquettes

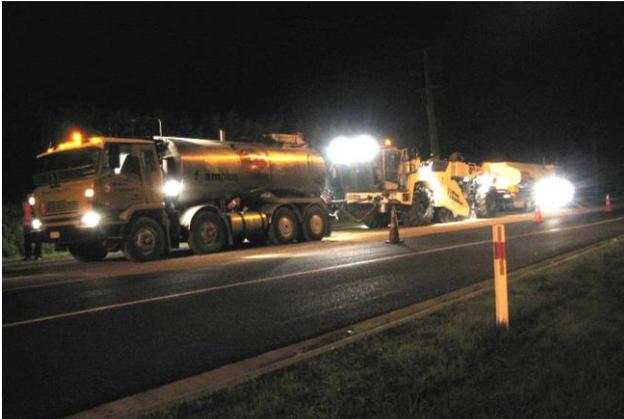
Figure 4: SH16 FBS – note cement spread on existing OGPA surfacing

Design and construction testing undertaken on the SH16 Coatesville-Riverhead Highway to Old North Road project incorporated seal coats and OGPA comprising typically 30 to 40% (and up to 50%) of the 180mm treatment depth. This confirmed that adequate FBS properties were comfortably achieved despite no pre-pulverisation phase and adopting a single pulverisation methodology to granulate surfacing and mix foamed bitumen / cement.

Mix design average: ITS (dry) 320 kPa, ITS (wet) 295 kPa, phase 2 resilient modulus = 900 MPa.

QA construction average ITS (dry) 250 kPa, ITS (wet) 235 kPa, phase 2 resilient modulus = 1150 MPa.

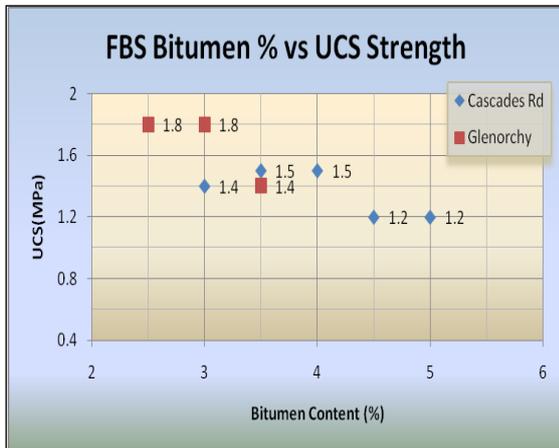
Figure 5: Bitumen % Vs UCS Strength

Hiways has undertaken FBS mix designs with a wide variety of bitumen contents to confirm optimum application. Increasing the bitumen content to a maximum of 5% by weight in 0.5% increments, to evaluate performance and the feasibility of producing cold mix 'asphalt', results only in increased cost and reduced strength and stability. The significantly increased cost due to binder quantity, and lesser performance, reinforces how the FBS process is suited to bitumen percentages ranging from 2.5 to 3.5% by dry weight for New Zealand aggregates, where a dependable second phase modulus of 800MPa is required.

Lower binder contents have also been evaluated, and strength/durability issues have been observed where the bitumen content drops to less than 2.5% (in particular the soaked to dry ITS strength ratio suffers). While these mixes (<2.5% bitumen) often don't meet New Zealand Transport Agency (NZTA) design requirements, these materials still provide superior performance to that of conventional treatments. The ability of current testing methodologies to confirm modulus and performance in a laboratory setting of very lightly bound mixes may understate interpolating their dependable field performance.

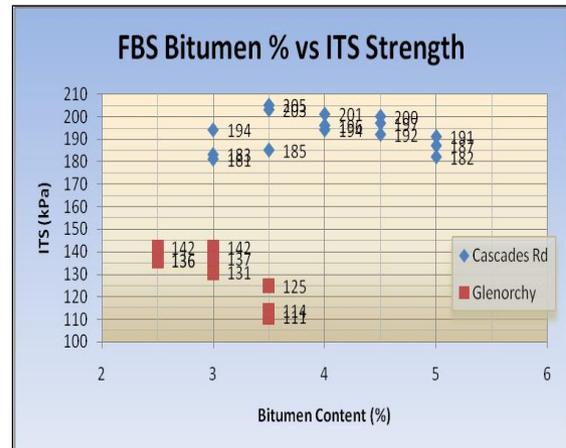
Figure 6: Bitumen % Vs ITS Strength

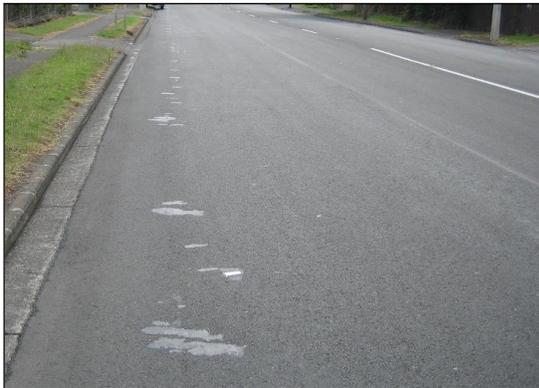
Figure 7: Membrane seal ‘bleeding’ through thin asphalt surfacing. Note line of ‘blooms’

Surfacing for some contracts undertaken soon after FBS was introduced to New Zealand resulted in flushing issues for seal coats and/or problems with binder rich membrane seals ‘flooding’ thin asphalt surfacing to the extent that instability developed in high stress areas. Seal design and surfacing needs to accommodate the unique properties of FBS basecourse.

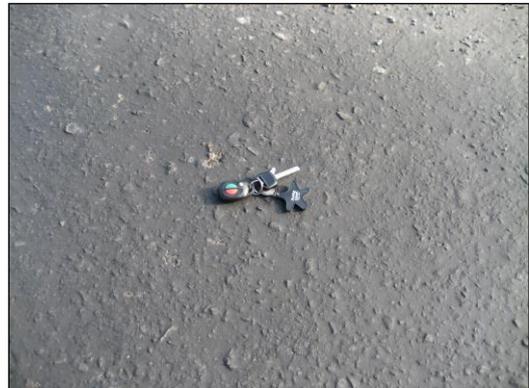
Figure 8: Common FBS Surface Finish

There have been a number of surfacing issues realised and addressed in NZ that are unique to FBS basecourse. The FBS process results in a finished surface that does not present the conventional “stone mosaic” finish as referenced in NZTA B/2 (conventional granular construction specification). The finished surface at sealing stage is very hard, but can be relatively smooth and ‘fatty’ - providing a low texture. While it is essential to maintain a slightly moist surface and undertake robust brooming prior to surfacing, it is also important to adjust the first coat or membrane seal residual binder application rate.

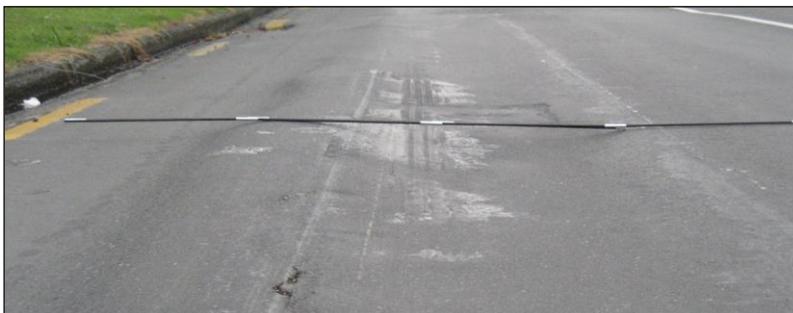
Figure 9: This picture shows rutting/shoving and an unstable asphalt surfacing in a high stress braking area. An investigation was undertaken to confirm causes.

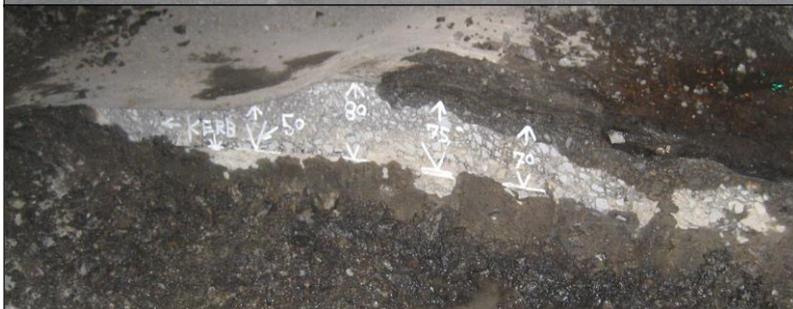
Figure 10: Trenching by the Client confirmed relief was entirely in membrane / asphalt surfacing with a level FBR surface

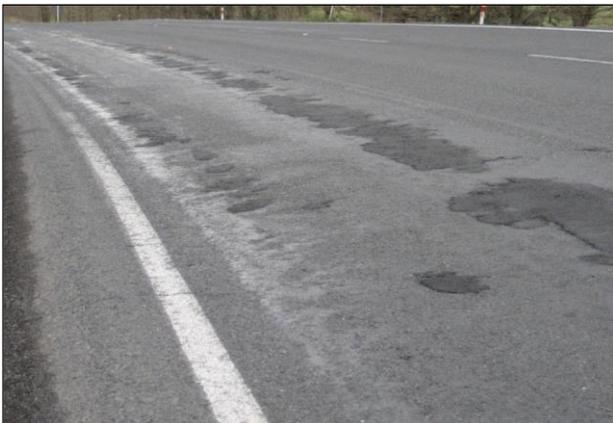
Figure 11: June '07 Primary wheel track repairs

Hiways were the FBS subcontractors for a contract on State Highway 1, Taupo (Central North Island) that was surfaced in mid-June 2007 (early winter for New Zealand). The sealing chip stripped from the emulsion seal coat and the seal coat was then lost from much of the wheel tracks on the night after surfacing. Inclement weather and cold conditions did not permit immediate remediation. A variety of temporary measures were adopted to ‘hold’ the site until a robust surfacing repair could be undertaken 4 months after initial construction. Much of the FBS basecourse surface in the wheel-tracks was exposed to traffic for extended periods, particularly through the last few weeks before remediation.

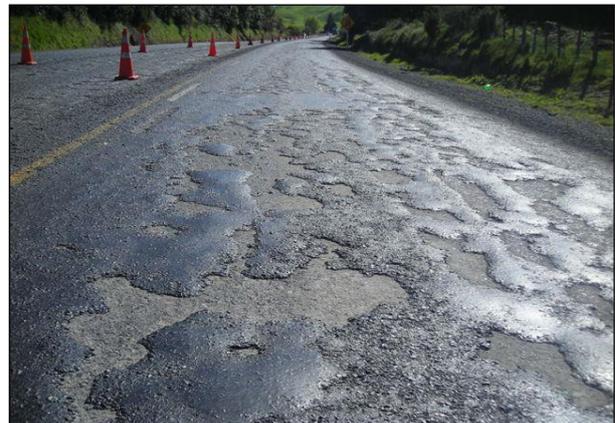
Figure 12: October '07 major surfacing failure

The first period of sustained warmer weather in October resulted in a major seal failure. The entire surfacing through the section mobilised and a very rough surface quickly developed exposing large tracts of the FBS basecourse which appeared to have maintained shape and surface finish. After consultation, the entire surfacing through the site was “scraped off” with a grader. The FBS surface was evaluated and found to be in adequate condition for resurfacing with no structural repair required.

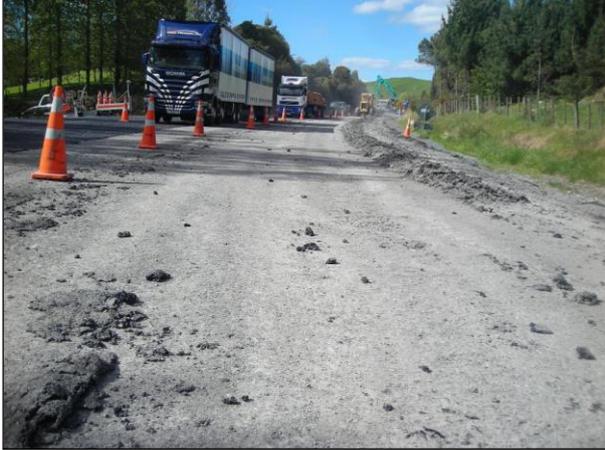
Figure 13: Removal of all seal

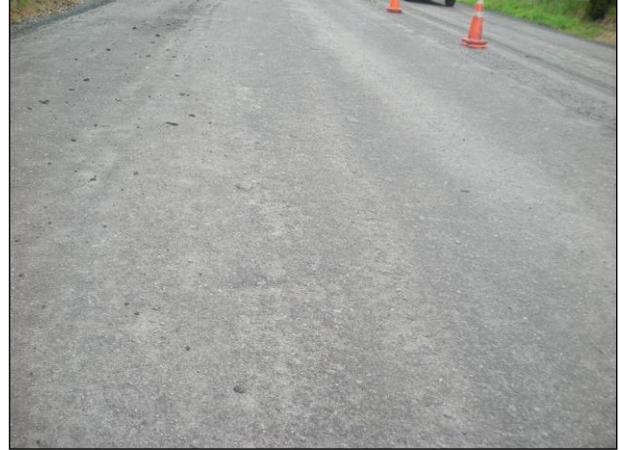
Figure 14: Exposed FBS basecourse prior to reseal

A new 2-coat seal was undertaken successfully with hot straight run bitumen. It is a testament to the unique properties of the FBS basecourse that it survived the environment and extreme traffic stresses (intense logging and dairy truck loading with 25 year design traffic 19.6×10^6 ESA) through the winter period without failure.

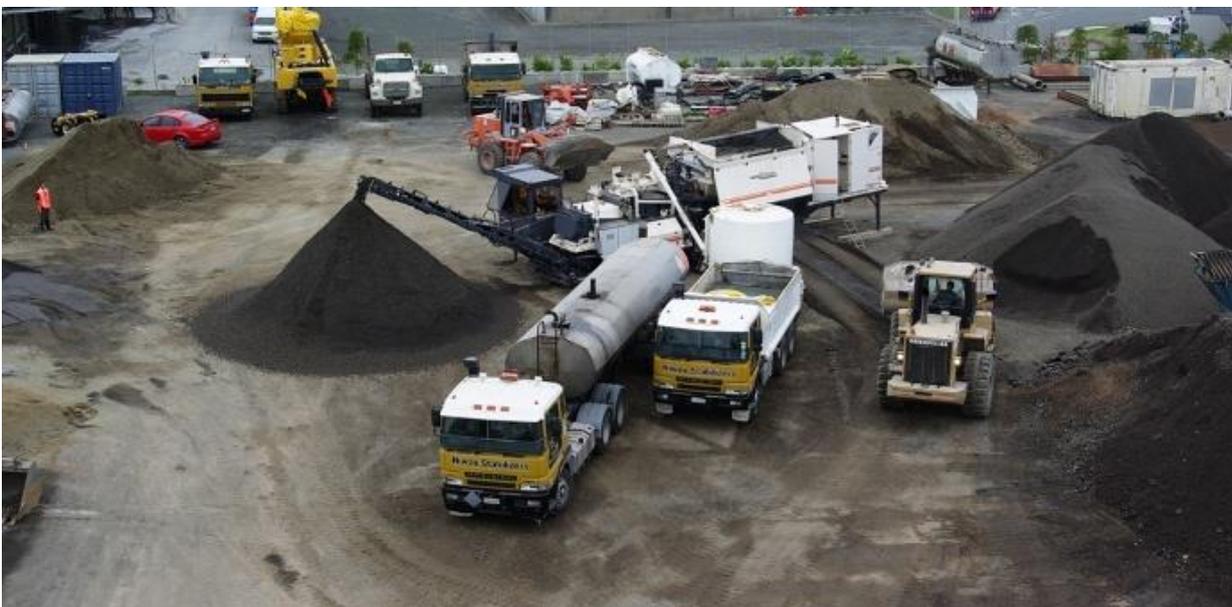
Figure 15: Ex-situ FBS basecourse production trials

Hiways recently purchased a Wirtgen KMA200 FBS pug mill to provide a mechanism for production of premium FBS aggregates in both storage (ex-situ stockpiled) and production (ex-situ treated then placing within 2 hours) mixes. This plant also provided a means of producing a wide variety of “fit for purpose” mixes incorporating and maximising the use of waste streams generated through various recycling and rehabilitation operations throughout Auckland City.

Some mixes with exceptionally good elastic moduli using various proportions of recycled aggregates, crushed concrete, RAP, glass, steel slag and fly ash have been developed. The challenge is in developing storage grade mixes that can generate adequate early life stiffness to be trafficked without requiring long periods of curing.

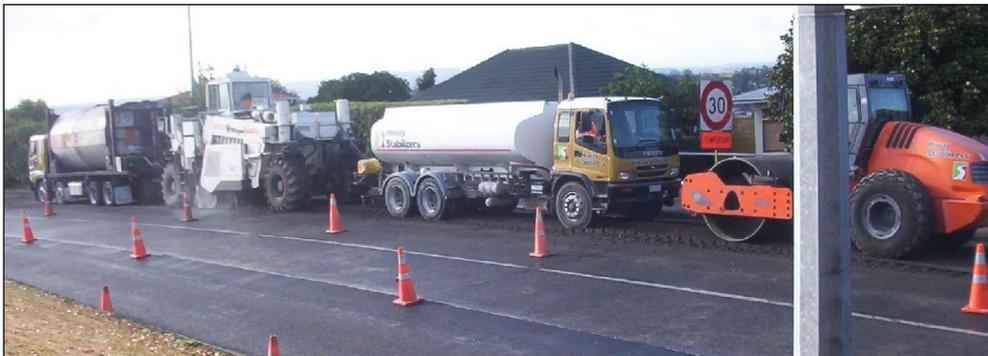
Figure 16: FBS in urban setting with an existing central concrete strip that was retained

Recent site evaluation has shown no visible modes of distress for the FBS basecourse. Site investigation via Falling Weight Deflectometer (FWD) testing has demonstrated the following:

- Design (10%ile) FBS Basecourse Resilient Modulus 800 MPa
- Average FBS Basecourse Resilient Modulus 3,020 MPa
- 10%ile FBS Basecourse Resilient Modulus 1,300 MPa

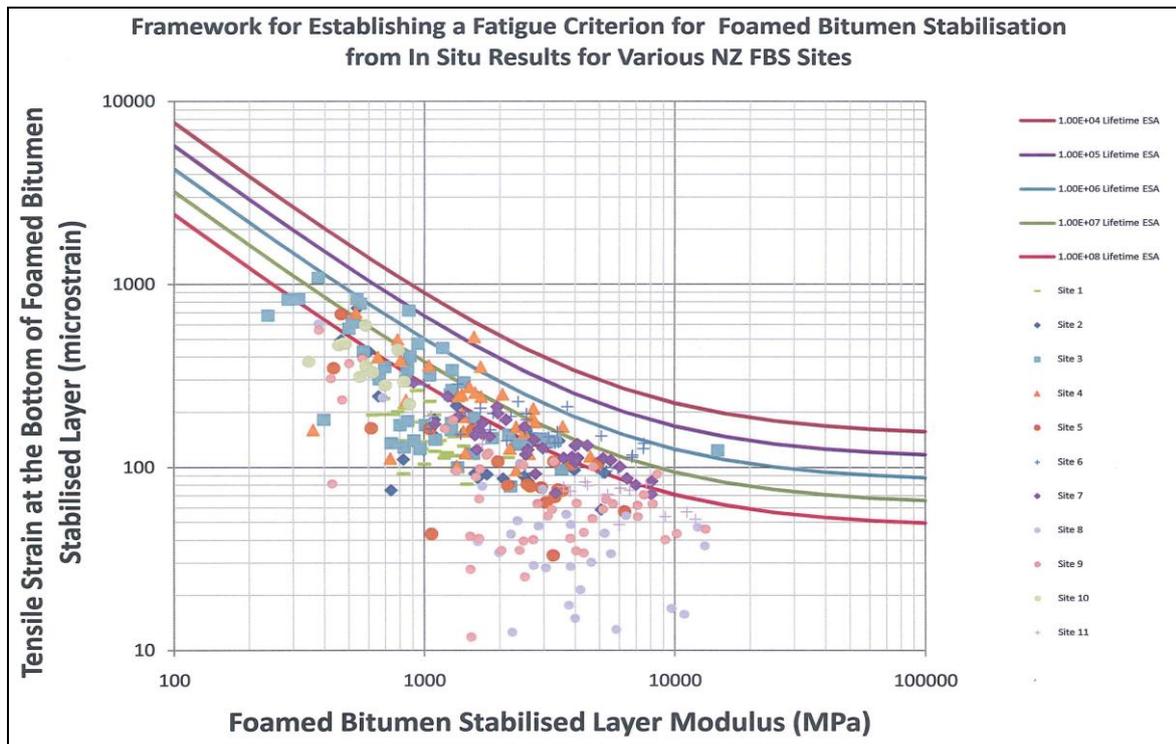
Figure 17: FWD Derived Basecourse Modulus vs Strain for New Zealand FBS sites.

This figure demonstrates the wide variety of interpolated modulus and tensile strain at base of the FBS basecourse for 11 sites throughout the North Island. While there are several localised points of marginal load capability and remaining life, none of the evaluated pavement sections could be classified as failing. A subsequent phase of this research is to carry out testing of the large quantity of 150mm diameter core samples from the test sites to validate tested second phase modulus against design expectations and post construction stiffness.

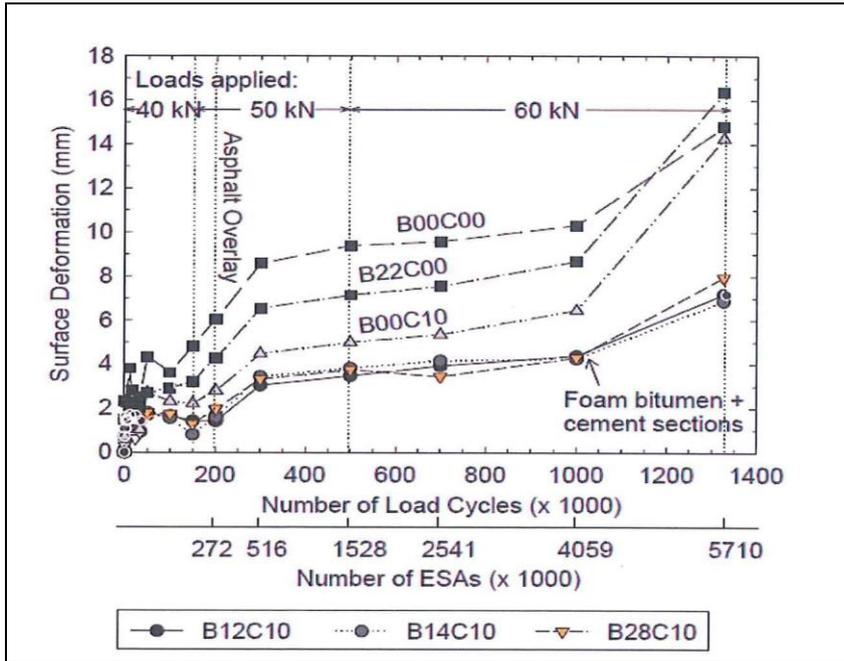
Figure 18: Rut Development Versus No. of Load Cycles for NZ CAPTIF Experiment

Figure 18 demonstrates how the conventional ‘design’ 8-tonne heavy duty axle (40 kN) loading was not sufficient to introduce significant rut development and this loading was increased to 60kN and water introduced to the pavement via saw-cutting and sprinklers to instigate distress. There was remarkably little difference in rut development for the three foamed bitumen and cement sections which demonstrated a rut progression in the order of 6mm / 1 million load cycles.

These results demonstrated that the addition of 1.0% cement provided superior rut resistance and fatigue capability for all three foamed bitumen and cement mixes, relative to the performance for mixes with foamed bitumen or cement only. The recommendation was that the addition of cement provides early life strength and improved stiffness / rutting resistance for the FBS basecourse. Furthermore FBS mixes utilising cement are more “constructible” while undertaking rehabilitations of ‘live’ carriageways with the ability to accommodate early trafficking.

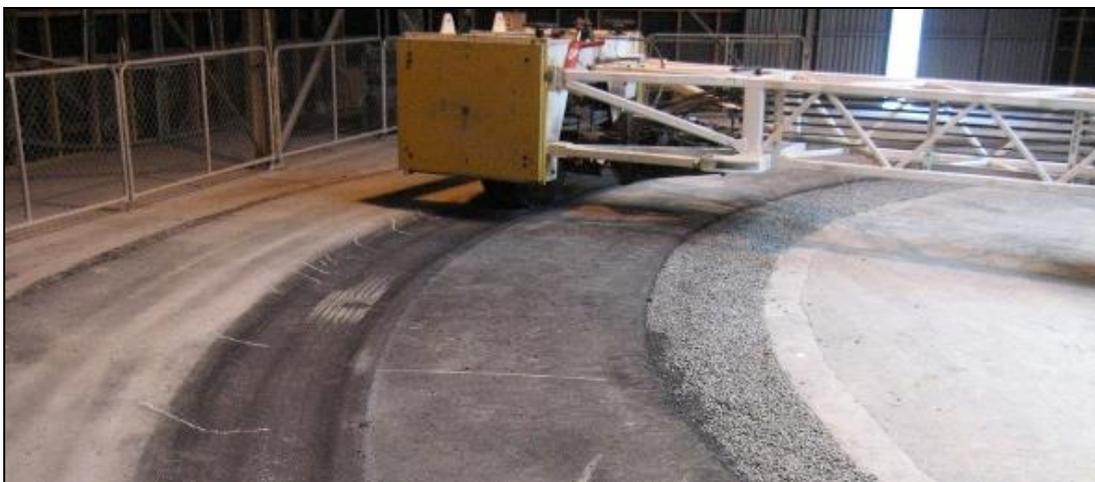
Figure 19: CAPTIF Testing for the Gonzalez FBS Accelerated Loading Experiment

Recently in New Zealand, a full-scale accelerated loading experiment was carried out (Gonzalez, 2009) of foamed bitumen pavements at the Canterbury Accelerated Pavement Testing Indoor Facility (CAPTIF). In this experiment, the same materials that were comprehensively tested in the laboratory (aggregates, bitumen, cement) were used to construct six different pavement sections, each with different contents of foamed bitumen and cement. Three were constructed using foamed bitumen contents of 1.2%, 1.4% and 2.8% respectively, plus a common active filler content of 1.0% cement. Two more pavements were constructed using cement only (1.0%), and foamed bitumen only (2.2%). In addition, one control section with the untreated unbound material was tested.
